The 26 July 2005 Dillon, Montana Earthquake

Michael Stickney

Montana Bureau of Mines and Geology at Montana Tech of The University of Montana 1300 W Park St Butte, MT 59701 mstickney@mtech.edu

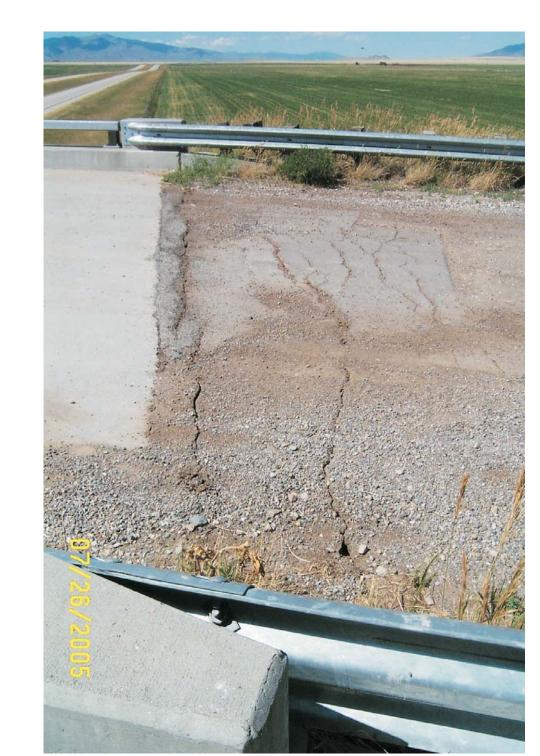
Ground cracks in approach to an Interstate 15 overpass 6.5 km southwest of main shock epicenter. View is to the north. Photo courtesy of the Montana Department of Transportation.

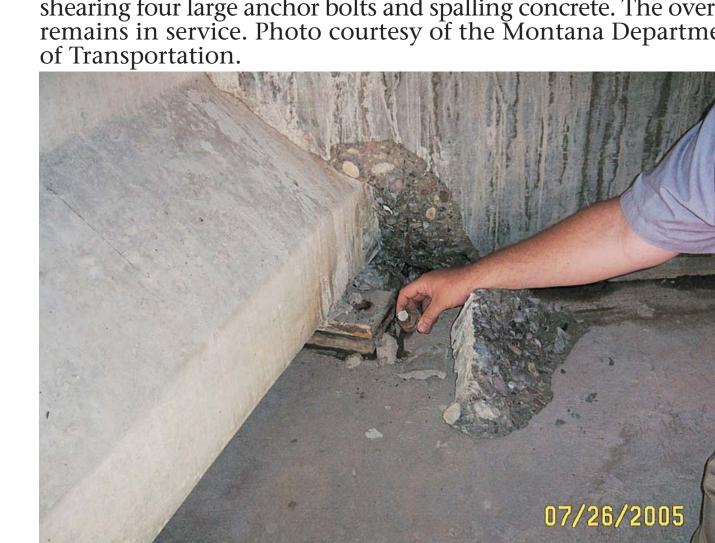
Damage to an overpass on Interstate 15, 6.5 km southwest of the main shock epicenter. Structural beams shifted on foundation, shearing four large anchor bolts and spalling concrete. The overpass remains in service. Photo courtesy of the Montana Department

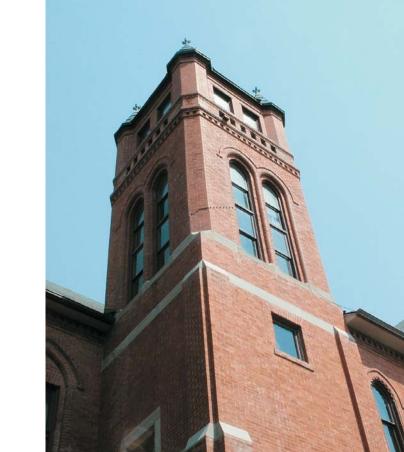
Crack in the south tower of Old Main Hall on the University of Montana Western campus in Dillon, approximately 16 km south of main shock epicenter.

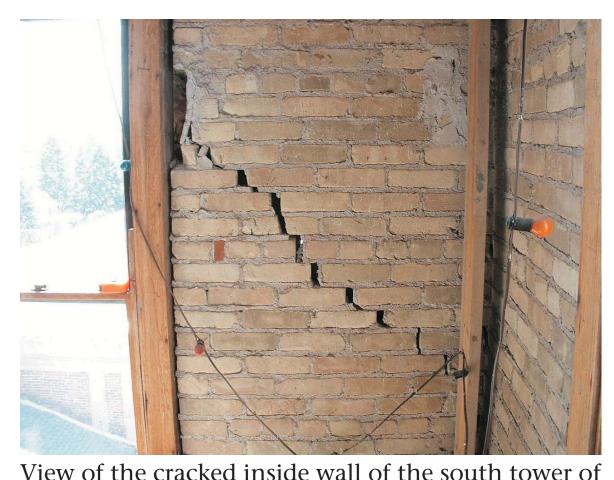
Old Main Hall. The fracture opened a few additional mm following a magnitude 3.9 aftershock on August 7. Note how bricks have separated from window frame

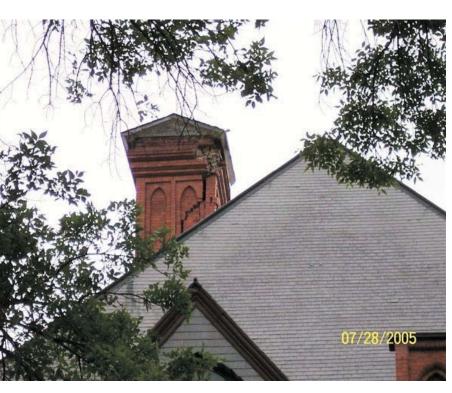
University of Montana Western campus. The chimney was removed several days after main shock to prevent total collapse.

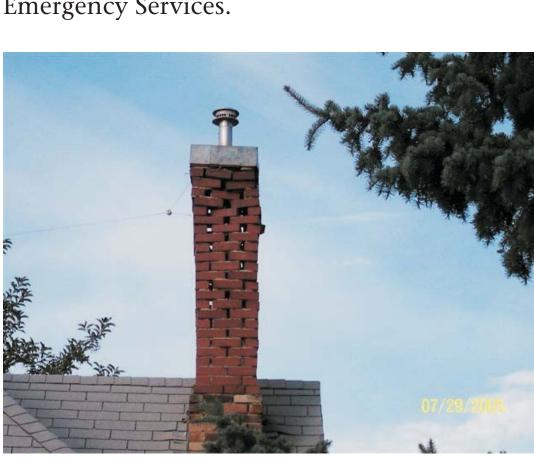
Up to 60% of the old masonry chimneys in Dillon were damaged by the earthquake. Fearing house fires and carbon monoxide poisoning after the heating season begins, county officials are requiring professional inspections of all masonry chimneys. Photo courtesy of Larry Laknar, Beaverhead County Disaster and Emergency Services.

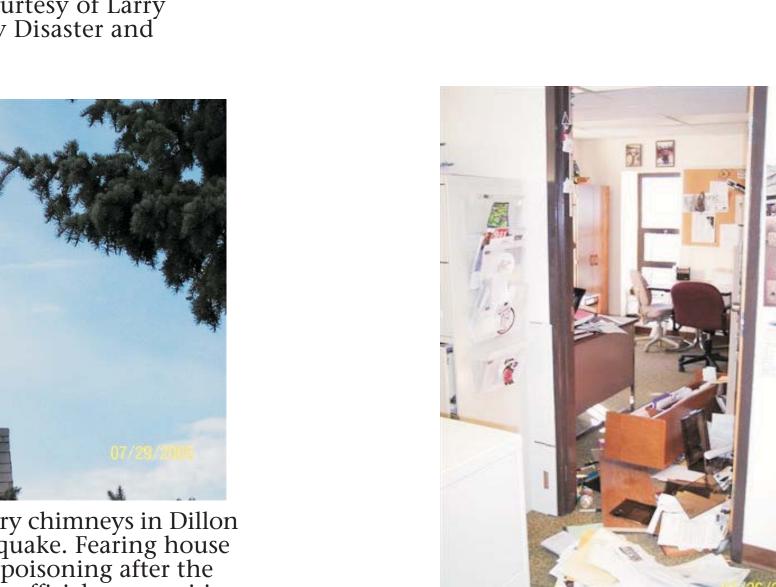
County planner's office in Dillon the morning after the earthquake. Photo courtesy of Larry Laknar, Beaverhead County Disaster and Emergency
